**REGINA V. MOASE  
IMPAIRED DRIVING CAUSING DEATH  
POLICE FILE 2012872043  
CHARLOTTETOWN RCMP**

# Technical Collision Investigation

## **Fatal Motor Vehicle versus Cyclist Collision**

2012-07-14 @ 18:03 hrs  
Route 13, Rennies Road, Queens County  
Province of Prince Edward Island

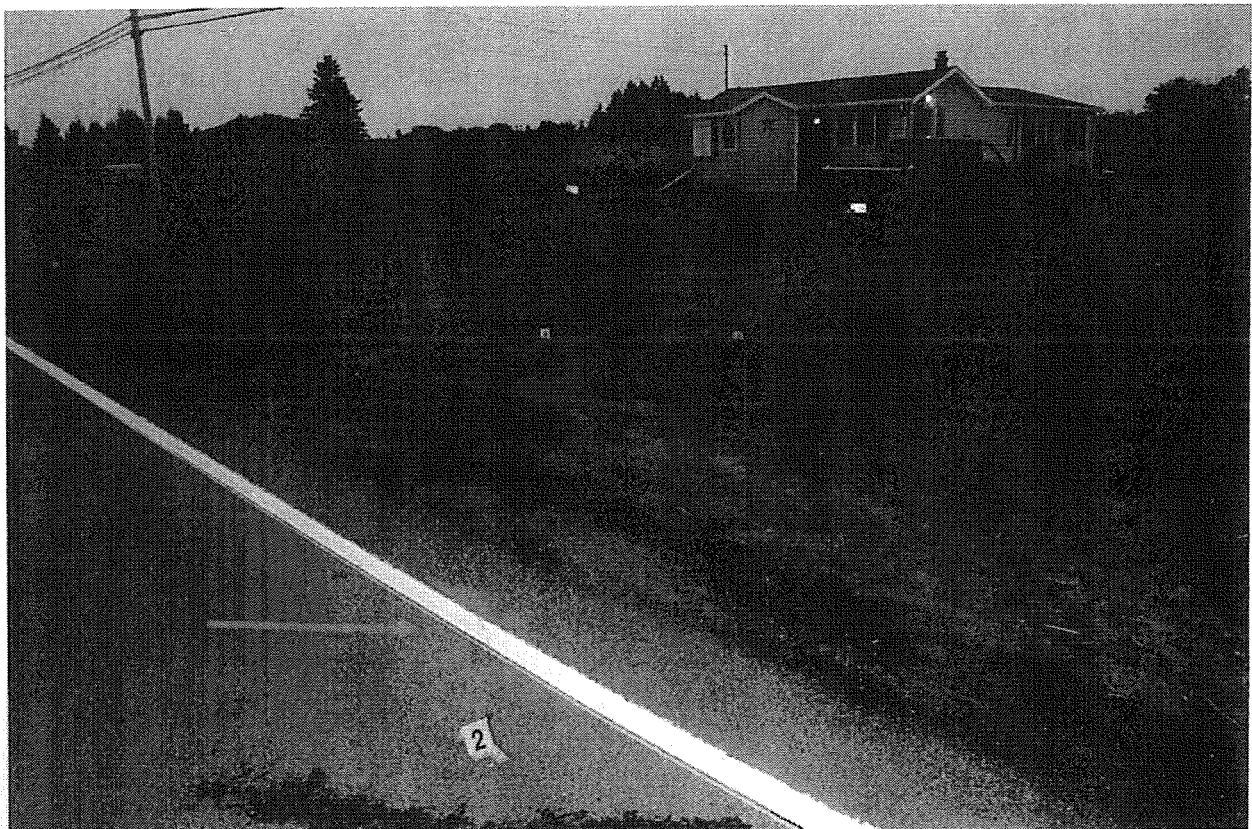
There was no obvious evidence in the north bound lane that any vehicle had braked, steered, or accelerated leaving tire mark evidence on the road surface in the area leading to where the deceased and her cycle had come to rest. I did locate a small black tire scuff mark, approximately 68 cm in length, leading off the asphalt road surface, across the white fog line near the driveway of 4760 Rte #13.

That particular tire mark was consistent with a bicycle tire being dragged across the asphalt road surface

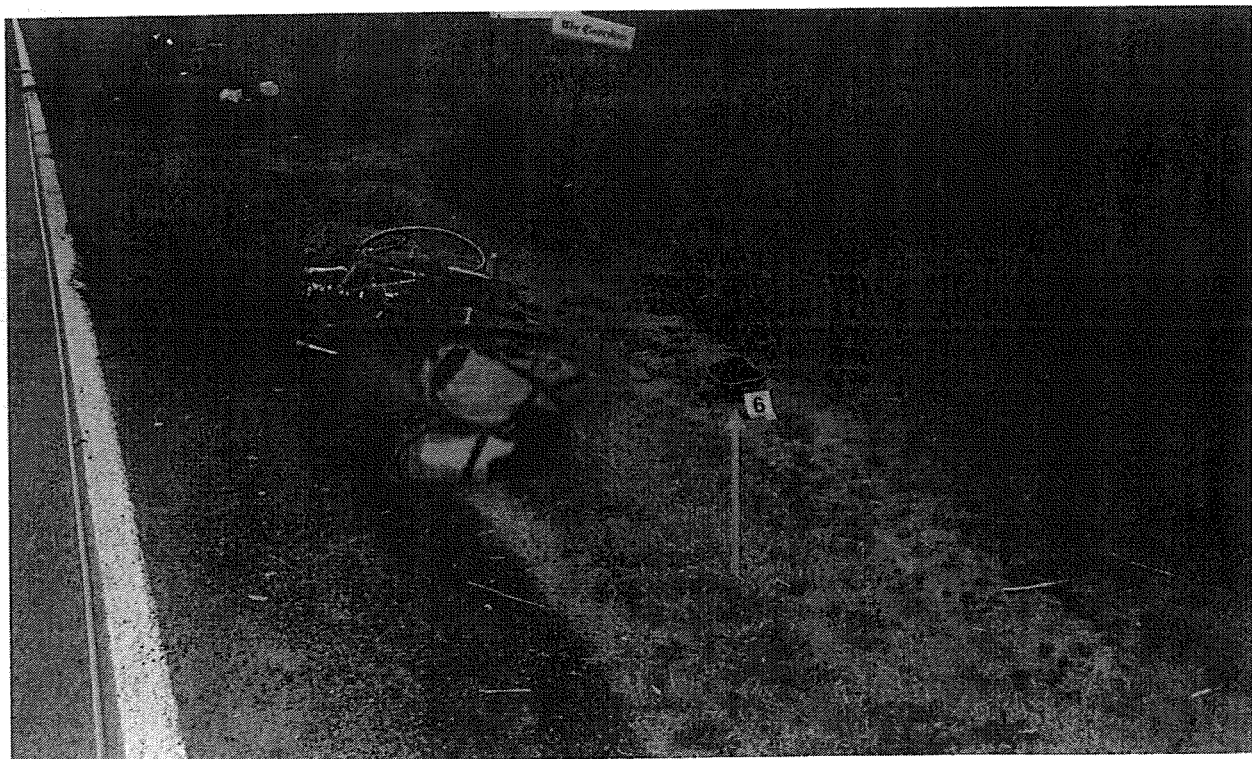
The last recorded observation was the location of a single headlight assembly located on the north bound lane shoulder near the deceased bicycle. That headlight assembly was the same color, and shape as the remaining headlight assembly on the Chevrolet van parked close by.
